I-64 Sherman Minton Bridge Inspection, Closure, & Structure Retrofit

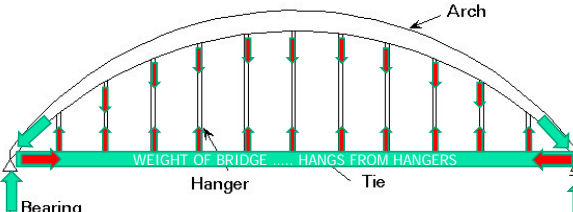
- Think of a bow (like in a bow and arrow....)
 - Stand it on a table like shown
 - Push down on the bow
 - What would happen if we cut the string?

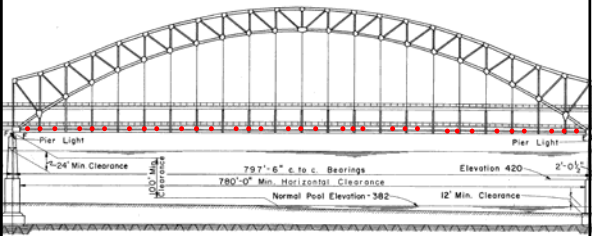
Diaphragm Lugs

33 diaphragms per tie x 2 ties x 2 spans x 8 lugs per diaphragm x 2 legs = 2112 welds

- ## Retrofit #1
- Remove diaphragm lugs & inspect
 - Retrofit lateral bracing connections & inspect
 - Core or install dog-bone detail based on results from inspection and fracture mechanics model

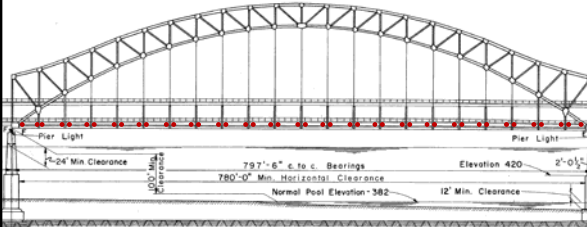
Tie Girder Welds

176 Individual welds per tie x 2 ties x 2 spans = 704 potential fracture sites

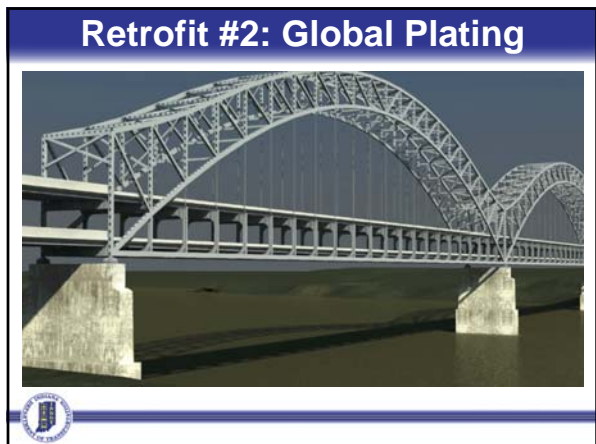
Top Plate: Dog Bone - Crack Isolation

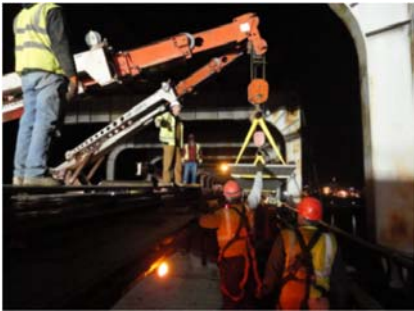
Field Drilled Holes for Bolts
